Re: Church of St Denis, East Hatley

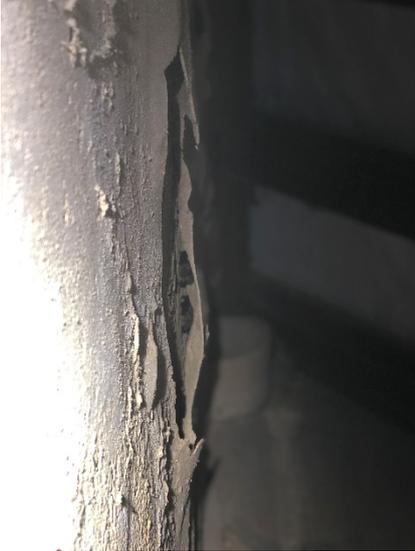
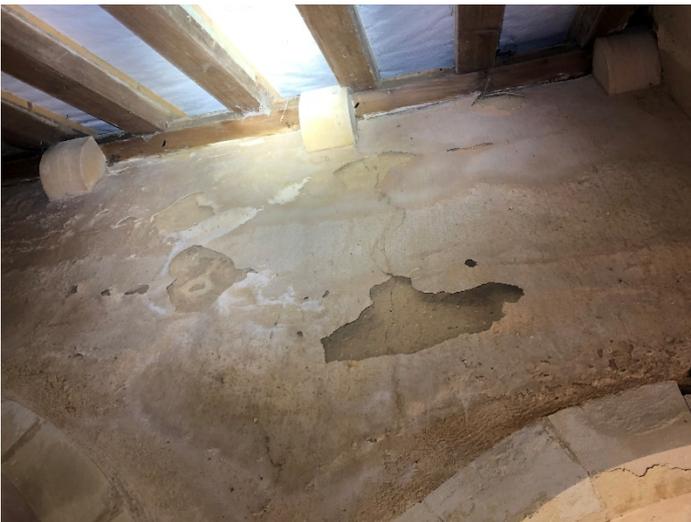
The quantity of bat droppings and insect feeding remains on the floor of the church had increased significantly on my second visit on 7 October 2019, and I also noted two brown long-eared bats roosting behind a patch of lifted lime wash on the wall next to the entrance porch on the north side of the Chancel – see photos overleaf.

Given the confirmed use of the void behind the peeling lime wash by roosting bats, care should be taken to check for the presence of bats behind such features as part of any future maintenance work. In event that bats are present and such features have to be disturbed, advice should be sort from a licenced bat worker. On the basis that peeling lime wash is a temporary bat roost feature (as it will eventually fall off), consideration should be given to the provision of a crevice roost bat box hung up in the same location as the peeling wash as a more permanent bat roost replacement in this part of the church.
